Richard B. Russell Dam and Lake
Savannah River, Georgia And South Carolina

Final Foundation Report

RICHARD B. RUSSELL PROJECT
SAVANNAH RIVER, GEORGIA AND SOUTH CAROLINA
FINAL FOUNDATION REPORT
CONCRETE DAM, EMBANKMENTS AND POWERHOUSE

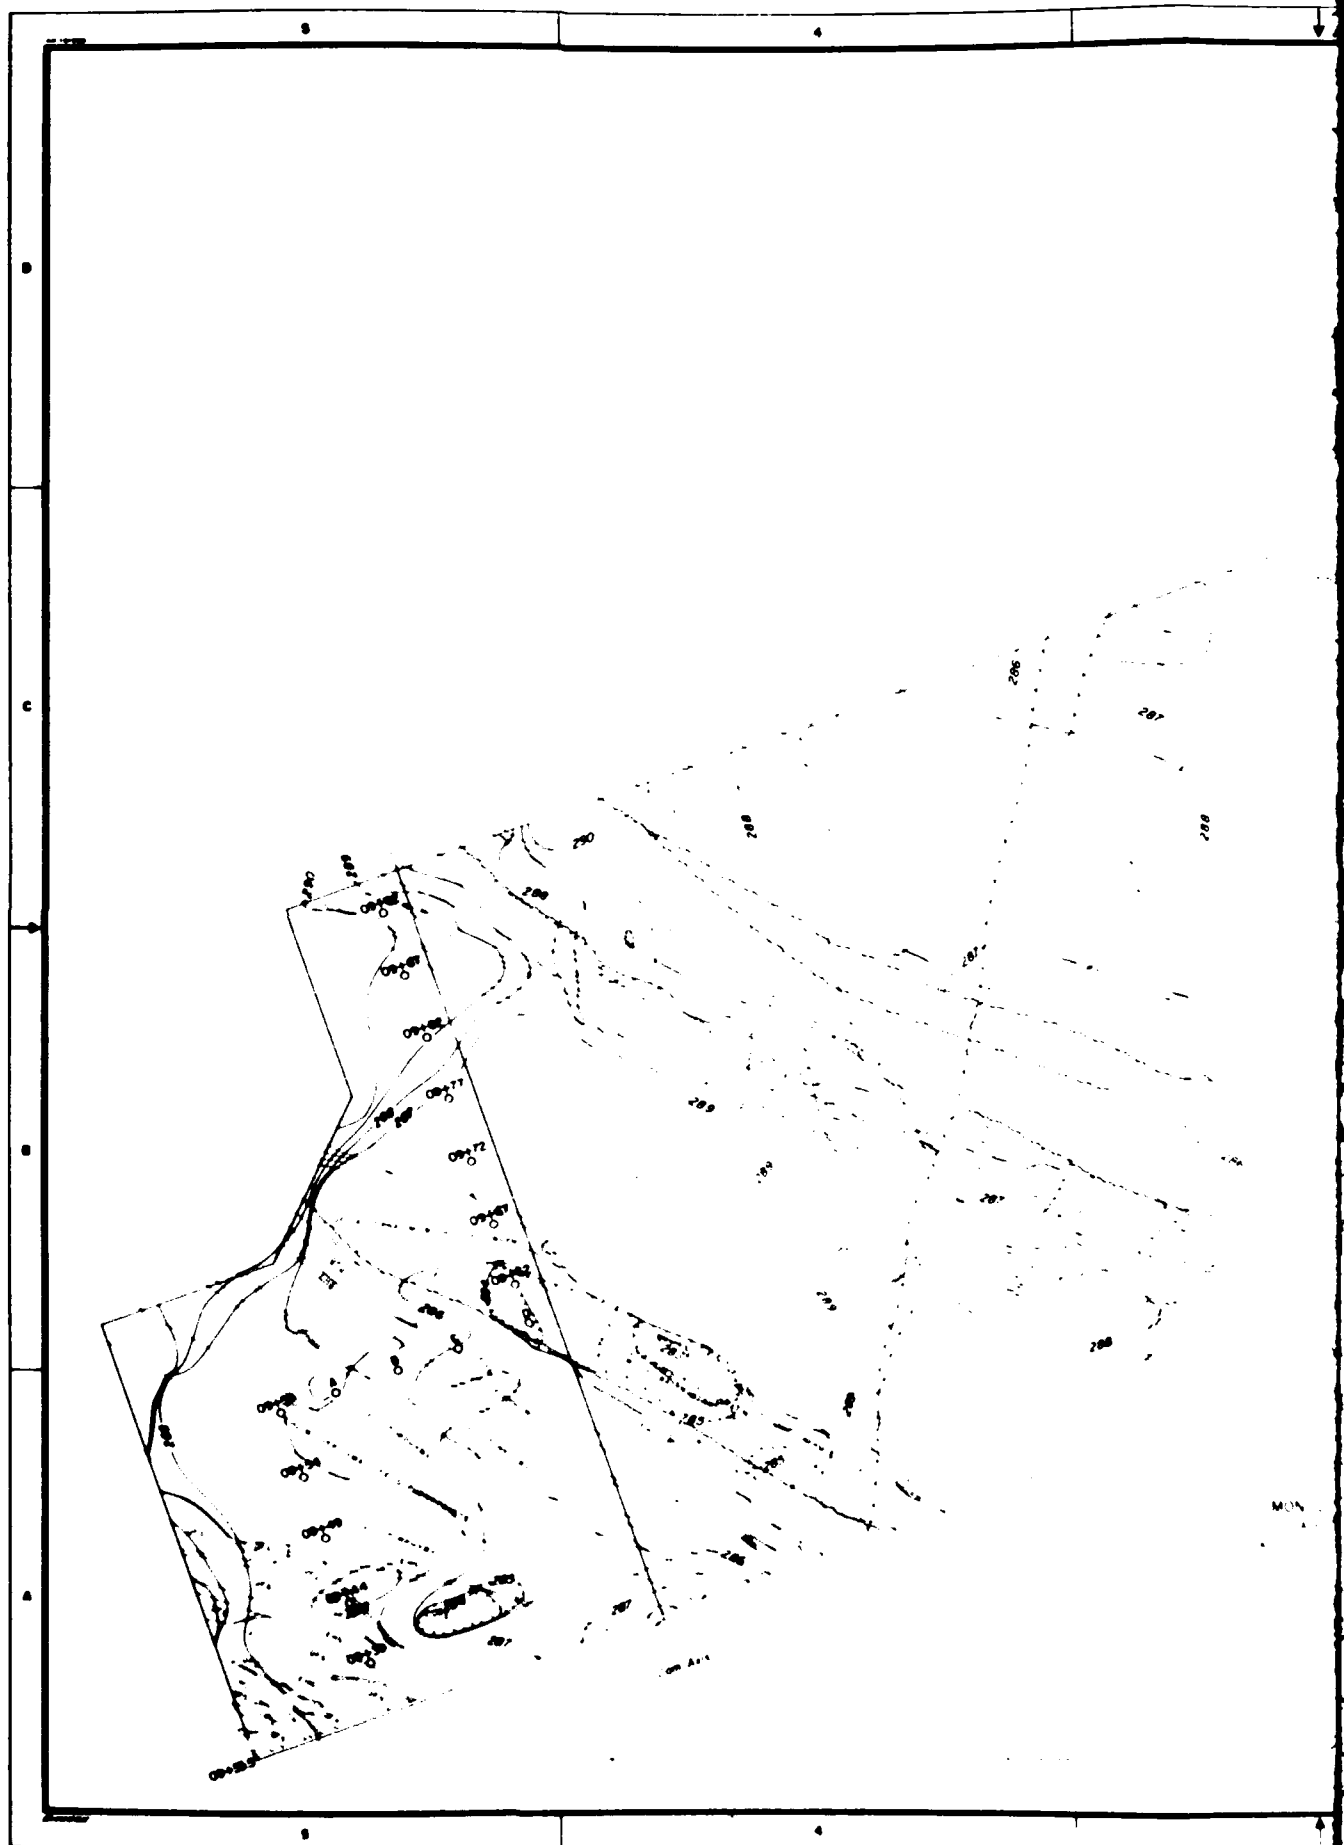
U S ARMY ENGINEER DISTRICT, SAVANNAH			
CORPS OF ENGINEERS			
SAVANNAH, GEORGIA			
FOUNDATION REPORT			
CONCRETE DAM			
MONOLITH 17			
RICHARD B RUSSELL PROJECT			
SAVANNAH RIVER GEORGIA AND SOUTH CAROLINA			
DATE	NO. OF SHEETS	SHEET NO.	PLATE
7	10-10-50	10	35
SCALE 1:5000			SHEET

MONOLITH 17
SCALE 1:5

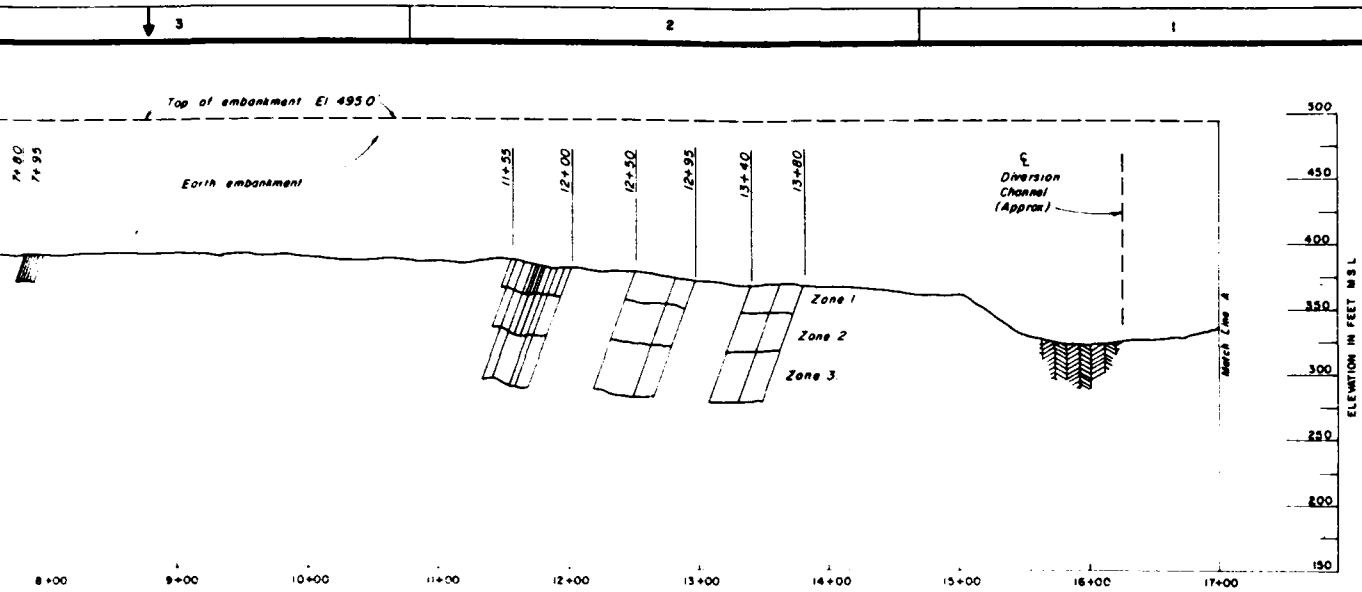
B-LINE CURTAIN GROUTING PROFILE

B-LINE CURTAIN GROUTING PROFILE - GEORGIA

1. For location of grout line with respect to dam centerline in plan view, refer to Plates 84 and 85.
2. For grout take data by zones, refer to Plates 86 thru 91.
3. For details of drilling and grouting procedures used, refer to Plates 10 and 11.

4.1-EE Overlap Grout Holes: In order to obtain effective grout coverage in the regions of the Georgia earth embankment where it abuts the concrete dam structure, a series of angled fan grout holes was designed. Drilling and grouting this pattern of grout holes permitted a consolidation of the embankment grout curtain and the grout curtain beneath the concrete dam. This fan arrangement is best understood by referencing Plates 86 thru 92.
